CASE STUDY

from
Southern
Water.

Sealing pipes with Tubogel to reduce groundwater infiltration in the Pan Parishes

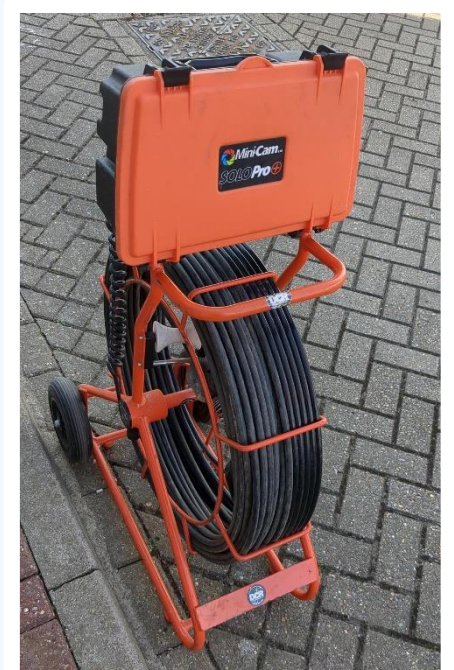
We use a flexible pipe camera to find damaged pipes →

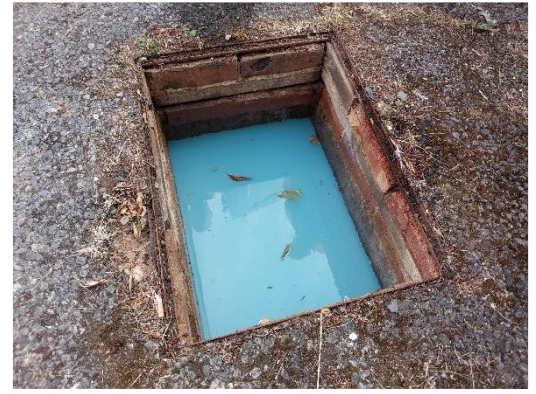
Tubogel is a two-part compound, meaning it works by one part reacting to the other. The first part is installed, which leaves a coating on the outside of the pipe through gaps, fractures or cracks. It's then followed by the second part, causing a chemical reaction to solidify the first part on contact. This process makes an extensive and enduring stone hard seal around any breaches or breaks in the pipe.

Part one of the formula
